DEPARTMENT OF PUBLIC UTILITIES

INCIDENT REPORT

22 Manning Street, Reading Massachusetts

January 25, 2010

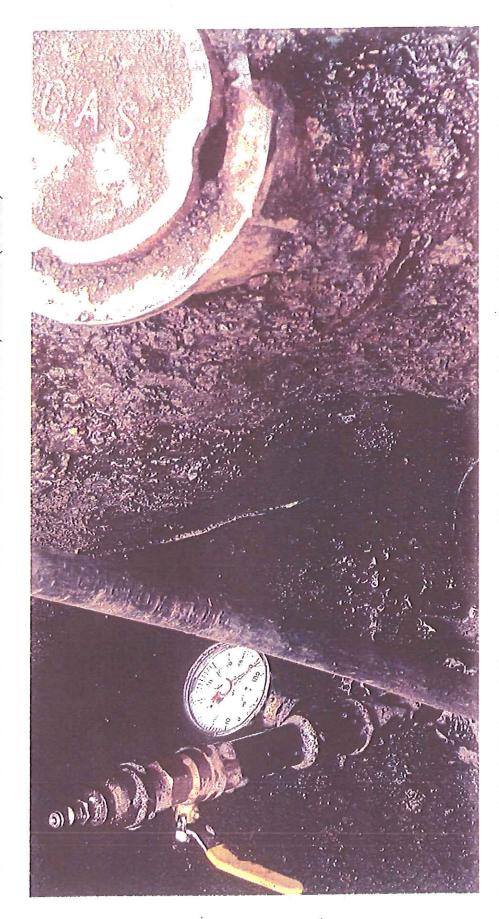
Pressure Test of Service to 22 Manning Street, Reading

On January 26, 2010, National Grid pressure tested the 1-inch service line supplying gas to 22 Manning Street, Reading for 15 minutes at 90 pounds per square inch gauge. I observed no loss in pressure.
